Basic Tree Evaluation Report

Evaluator: AJW
 Tree #: 9
 Date (00-00-00): 8/22/2013
 Tree ID (#,date; e.g., 12,2-6-13): LA9,8-22-13 Total Score: **35**
 Species: Acer saccharinum Silver Maple Ave = 40
 Location (Address): Biltmore Lake Clubhouse, 80 Lake Drive, Enka, NC 28728
 Location On Site: Between clubhouse patio and beach
 Size: DBH inches 25.8 Est. HT feet 75 Est. WD feet 40

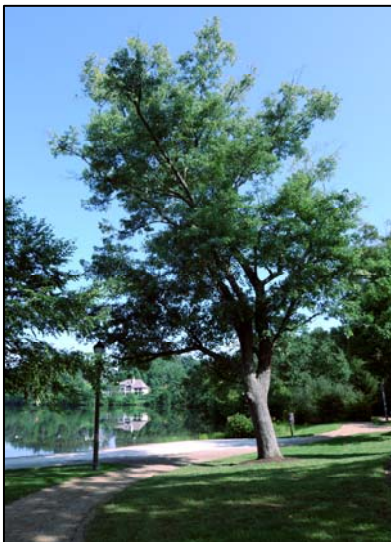
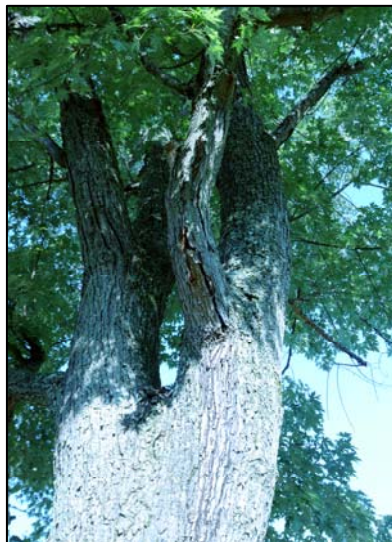
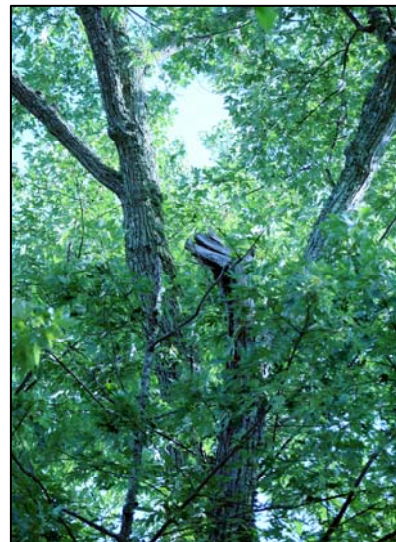
Score
1. Initial Impression: Appears Healthy / Vigorous / Good Condition.....	Unhealthy / Stressed										
	10	9	8	7	6	5	4	3	2	1	4
2. Site Location: Good Siting / Design	Poor Siting / Design										
	10	9	8	7	6	5	4	3	2	1	5

3. Structural Integrity: Appears Sound, No obvious str'l prob	Obvious Major str'l prob(s)										
	10	9	8	7	6	5	4	3	2	1	5
4. Wounds: None Obvious	Many										
	10	9	8	7	6	5	4	3	2	1	4

5. Insect / Disease Problems: None Obvious	Many										
	10	9	8	7	6	5	4	3	2	1	5
6. Branching Structure / Pattern: Good, typ'l of species	Poor, atypical										
	10	9	8	7	6	5	4	3	2	1	4

7. Root System: Root Flare Appears Healthy, Root Zone Undisturbed	Damaged Root Flare, RZ Disturbed										
	10	9	8	7	6	5	4	3	2	1	4
8. Final Overall Impression: Very Favorable	Very unfavorable										
	10	9	8	7	6	5	4	3	2	1	4

9. Tree Needs:	Prune		Cable	Mulch	Aeration	I / D Control	Nutrition				
	Drainage		Irrigation	Removal	Protection	Further Evaluation
