Pre-Construction Tree Evaluation for Pisgah Manor

Andy White, Registered Consulting Arborist #510

July 11, 2011

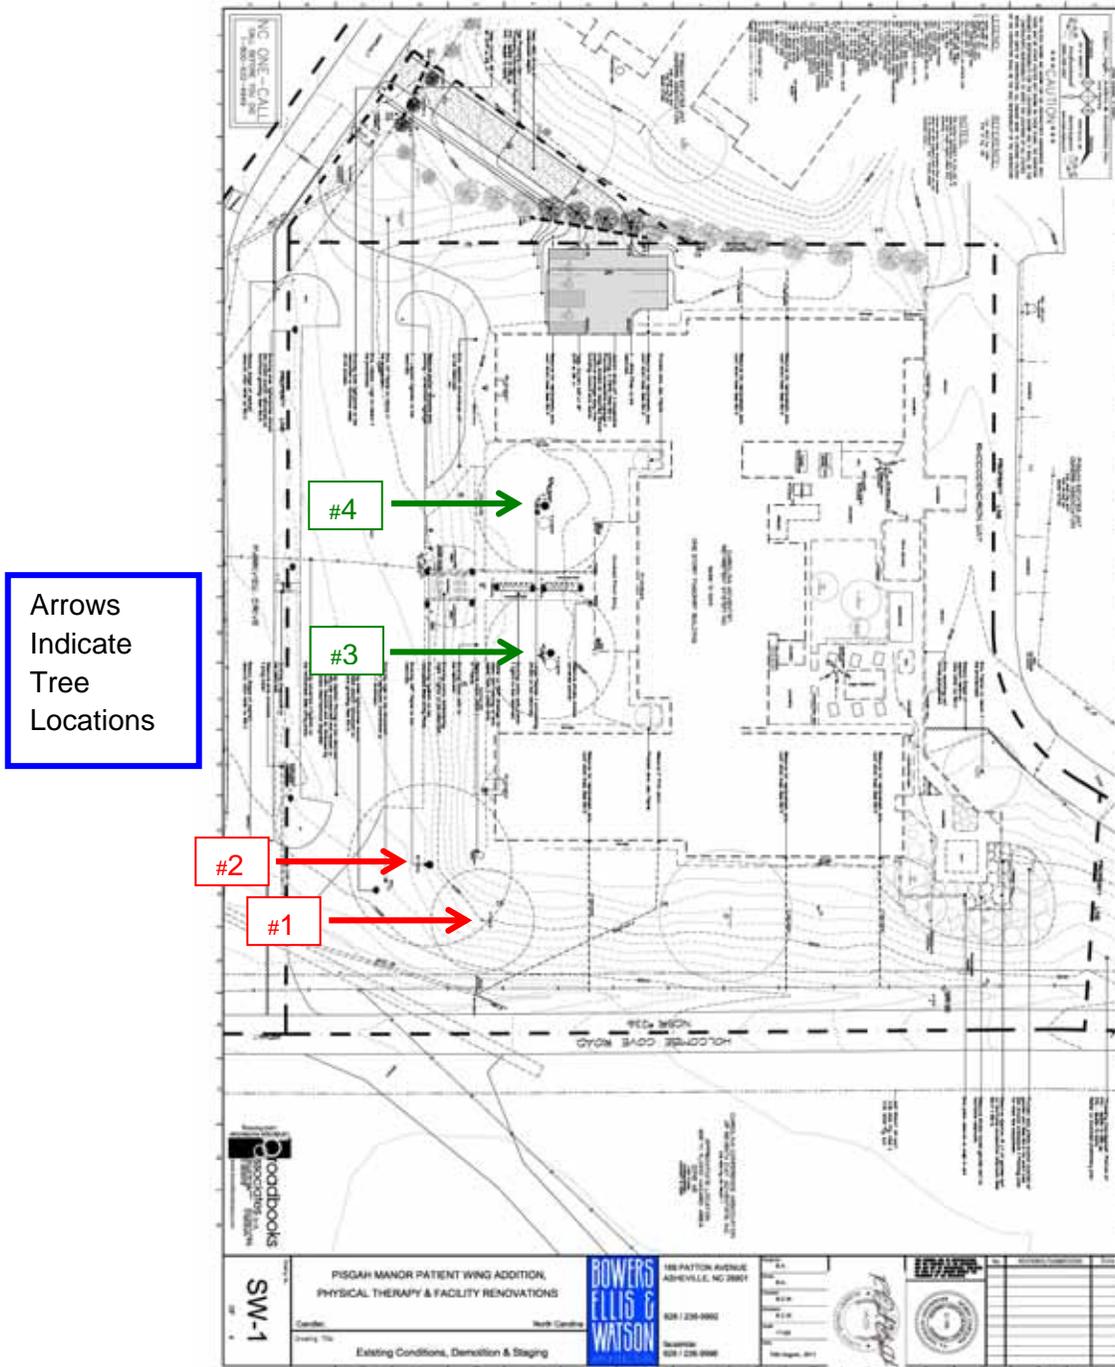
Appendix A – Site Plan #1, Existing Conditions

The other two trees in question, also noted as "Maples" on the architect's "Existing Conditions" plan (see Appendix A – Site Plan #1, green arrows), are located in areas that appear to be outside of the zone of direct construction activities (see Appendix A – Site Plan #2, green dots). On paper, these two trees (designated as Trees #3 and #4 in this report) appear to be salvageable if given proper protection during construction. The issue with these two trees is that completion of the new building addition will severely limit future access to them; they will be situated in a large, enclosed courtyard with severely restricted access for future care and maintenance. At this time, Mr. Kidder mentioned that these trees have many surface roots, which are proving to be

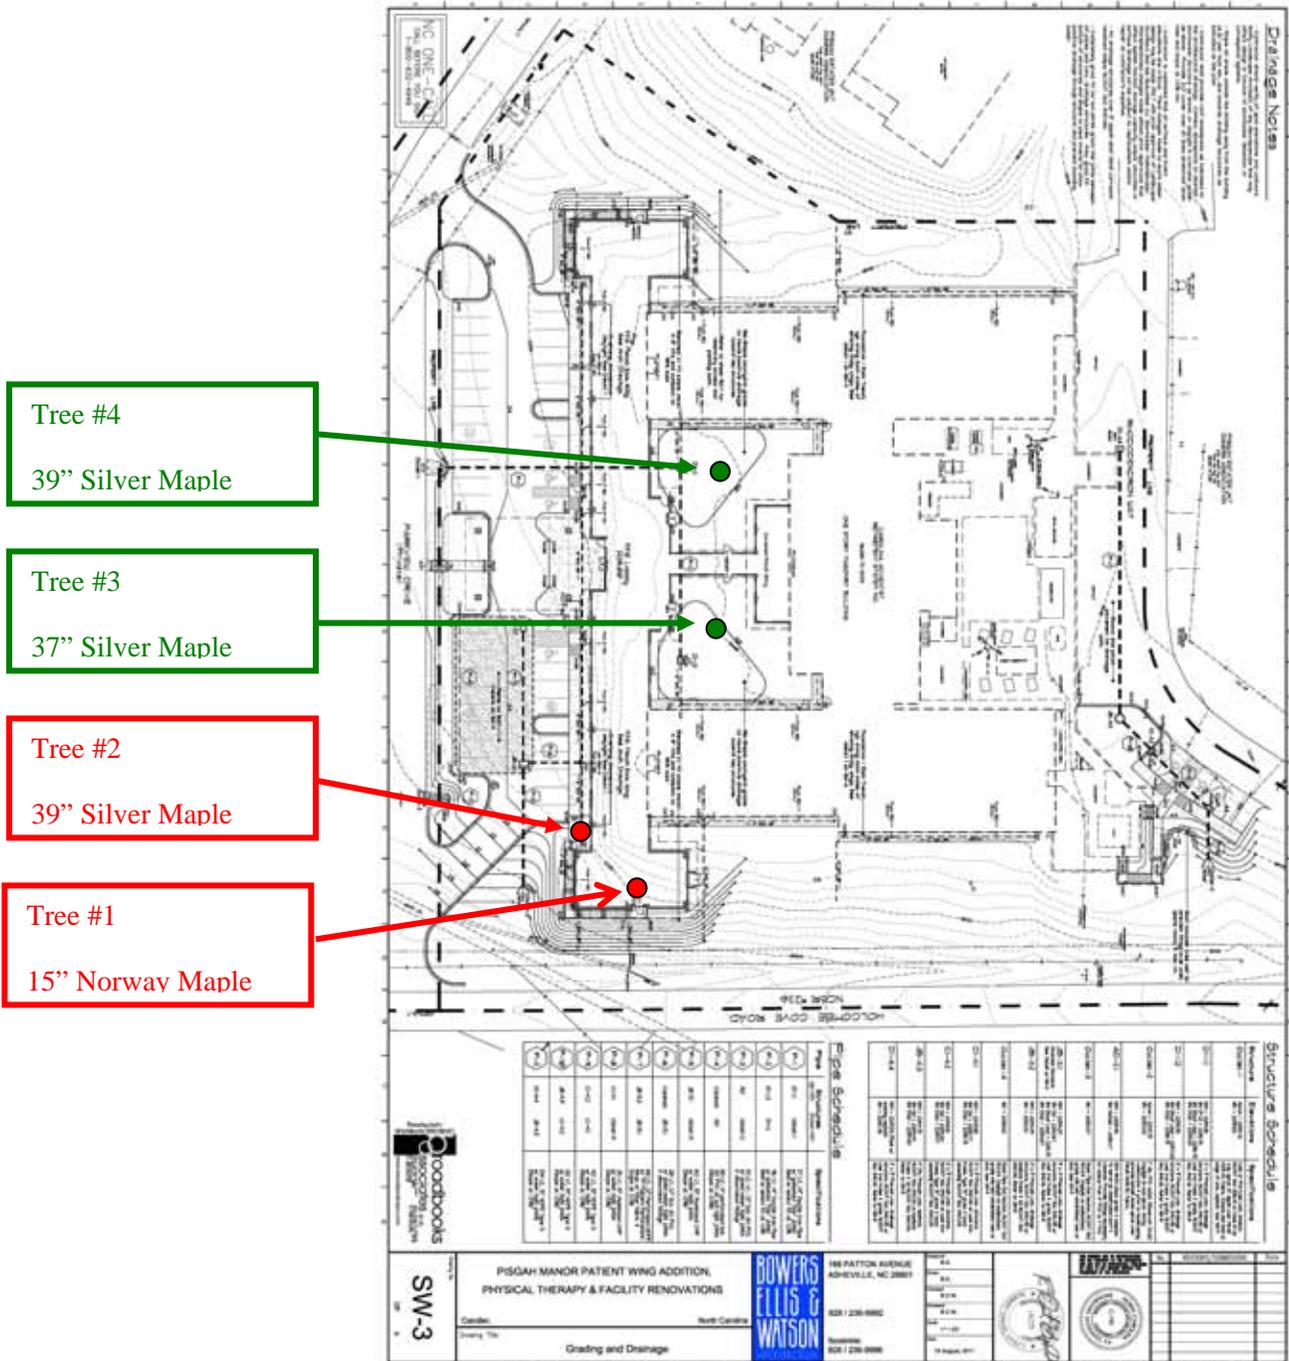
Appendix A – Site Plan #2, Location of Trees Relative to Proposed New Construction

While reviewing the plans in Mr. Kidder's office, it became apparent that two of the four trees in question (designated as Trees #1 and #2 in this report) are located well within the confines of the new building addition (see Appendix A – Site Plan #2, red dots). These two trees, noted as "Maples" on the architect's "Existing Conditions" plan (see Appendix A – Site Plan #1, red arrows), cannot be preserved if the current building plans are implemented. We decided that I would verify the location of these two trees with respect to the proposed construction, and if the plans were accurate I would not further evaluate these two trees.

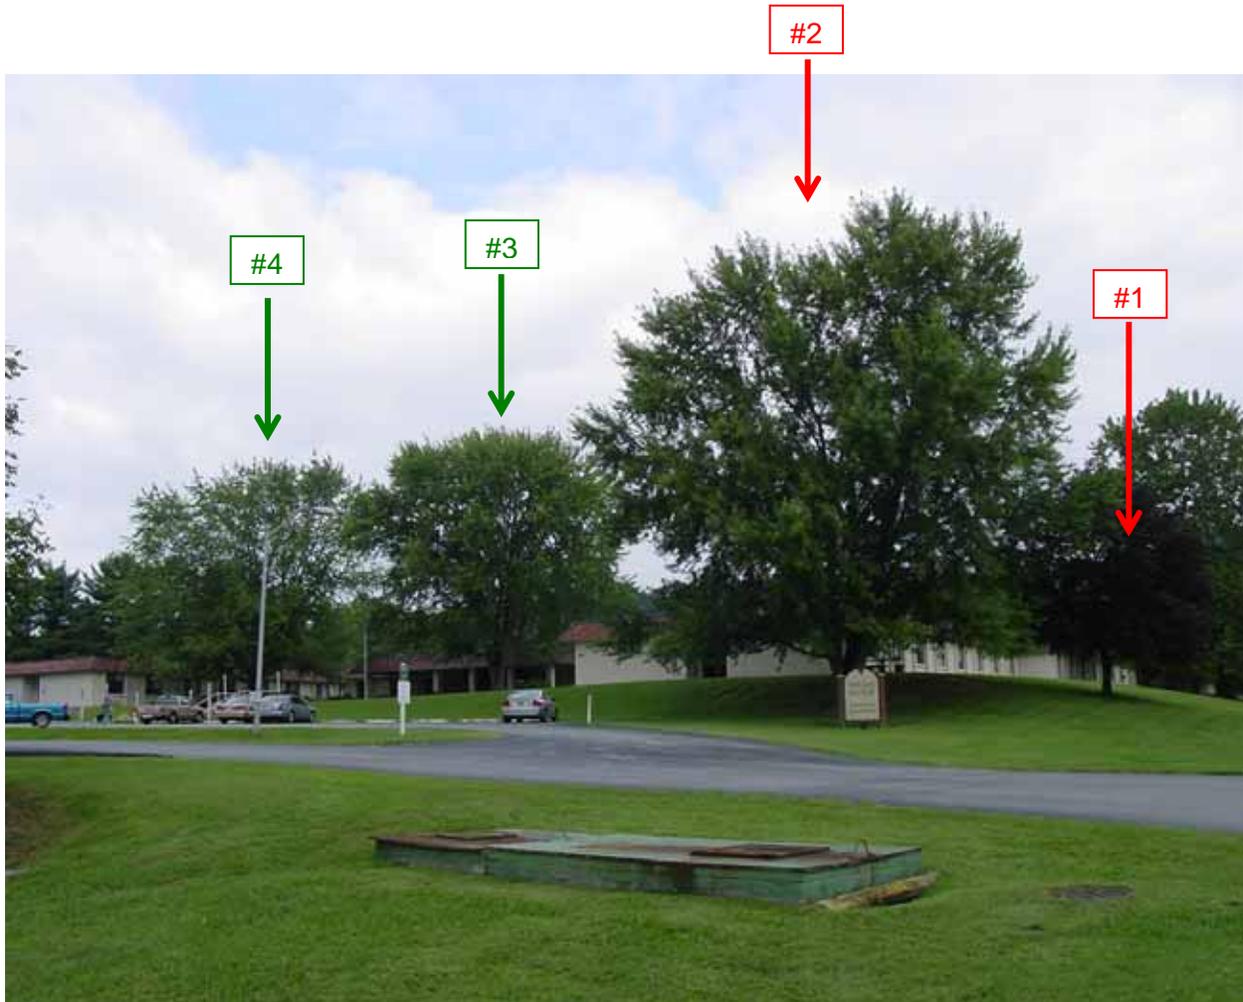
Photo 1 – Pisgah Manor, 95 Holcombe Cove Rd., Candler, NC 28715. The four trees evaluated in this report are marked with colored arrows. **Red color signifies definite need for removal; green signifies outside of construction zone.**

1. Remove Trees #1 and #2. They lay within the perimeter of the proposed new building addition.
2. Remove Trees #3 and #4. This is in keeping with the reason for the new building addition and renovation work, which is to prepare for the future. These trees served their purpose well for the past 35 + years, but they will become a hindrance as they get older. They already limit the use of the space, and this will never improve as long as they exist. Their removal will allow for more and better use of the space. If properly designed and built, a new outdoor living area in this space will be a big asset to the facility, one that will be thoroughly enjoyed by current and future residents, visitors, and employees. The trees will be sorely missed, especially at first, but over time the benefits of the new outdoor living area will take over.

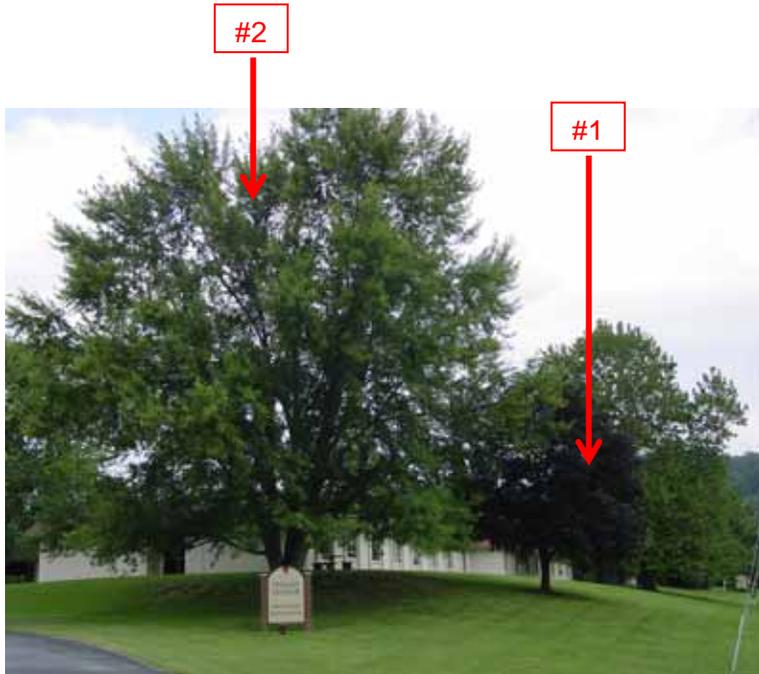
After reviewing the plans in Mr. Kidder's office, I walked a short distance to where the trees are located and conducted my site evaluation. I first examined the two trees that are shown on the plans to be located within the walls of the future building addition (see Appendix B – Photo 2, Trees #1 and #2). I verified that these trees are located as marked on the plans (see Appendix A, Site Plan #2, red dots), and made note of their need for removal. I positively identified the trees in question as a 15 inches in **diameter at standard height (DSH)** Norway maple, *Acer platanoides* 'Crimson King' (designated Tree #1) and a 39 inch silver maple, *Acer saccharinum* (designated Tree #2). **Note: bold terms are defined in the Glossary, page 9.** Measurements were taken with a **diameter tape**. Identification of the trees was made using resource manuals (Dirr, 1990, Graves, 1956) brought with me to the site. Since these trees were scheduled for removal, no more time was spent measuring and evaluating them.

Photo 2 – Trees #1 and #2 at Pisgah Manor. These trees are within the proposed new building addition, and will need to be removed.

Trees #1 and #2 will be removed since they lay inside the perimeter of the proposed new building addition.

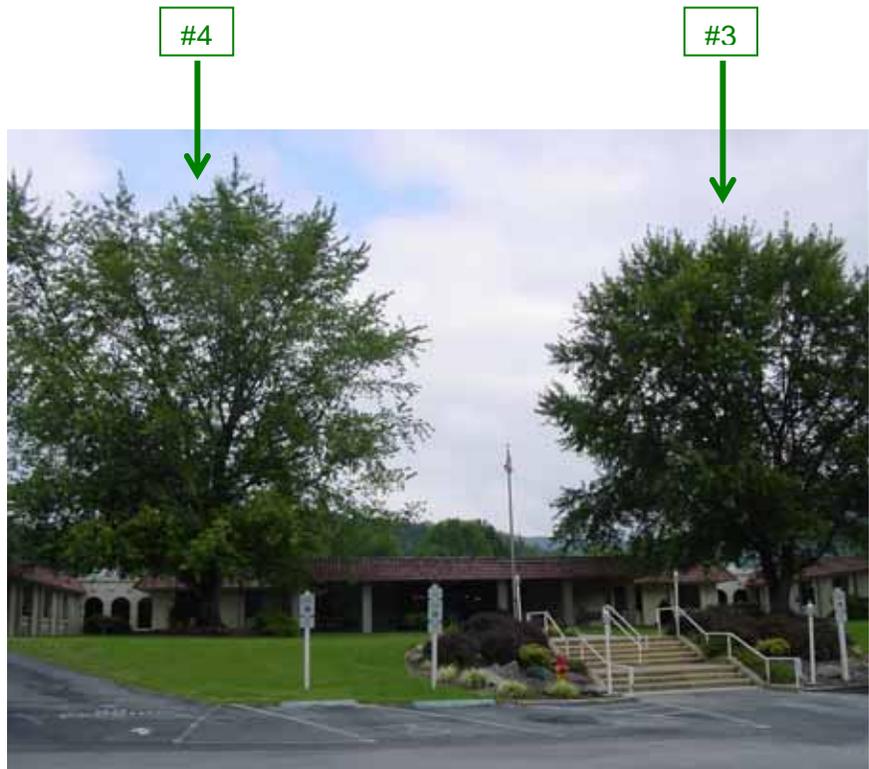
Next, I visually inspected the other two trees in question. These trees are both identified as silver maples; one measures 37 inches in diameter at standard height (designated Tree #3) and the other measures 39 inches in diameter (designated Tree #4). They are located as marked on the architect's "Existing Conditions" plan (see Appendix A, Site Plan #1, green arrows). Both of these trees appear to be healthy, mature specimens. Their age is estimated at about 40 years old; this is based on the age of the building (36 years old) and David Kidder's recollection that the trees were small, maybe 6 inches in **diameter at 12 inches**, when he first started working at Pisgah Manor in 1986. Both trees have a **crown** spread of approximately 60 feet and height of 70 feet – estimated by using relative comparisons of nearby structures and objects of known size (see Appendix B – Photo 3, Trees #3 and #4) Both trees had been pruned several months earlier and their **Cobra® cabling systems**, which were installed 5 years previously, were replaced / repositioned at that time (see Appendix B – Photo 4). The trees have good **root flare** and **trunk taper** (see Appendix B – Photo 5). There are no obvious signs of disease, decay, or insect infestation. Their limbs are normal in size and distribution. **Crotch angles** are typical for the species; no dangerously acute angles are observed (see Appendix B – Photo 6). The foliage appears normal in color and volume. The **apical growth** has ranged from 10 to 12 inches over the last 5 years. There is considerable mounding at the base of the trees caused by expanding tree roots pushing the soil up above them (see Appendix B – Photos 5 and 7). Both trees have numerous surface roots, both under the **canopy** and extending beyond (see Appendix B – Photos 7 and 8). Many of the larger, more prominent roots have numerous wounds caused by repeated encounters with lawn mower blades over many years. Surface roots are observed close to the building foundation (see Appendix B – Photo 9). The **drip line** environment of these trees consists of lawn area, concrete walkway, and river stone mulch along the building foundation.

Photo 3 – Trees #3 and #4 in front of Pisgah Manor.

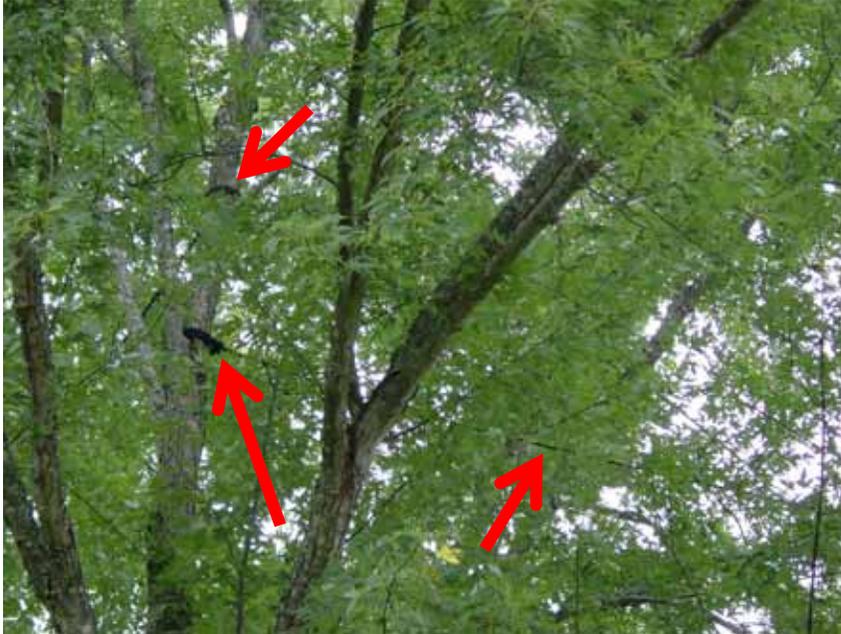
Five years ago we recognized the potential danger these trees posed to the building, surrounding environment, pedestrians, and the trees themselves in the event of major limb / trunk failure. At that time we proactively installed Cobra® cabling systems to provide some protection. The cabling systems have a two-fold purpose: first, to provide support to major branches / trunks to help prevent breakage in storm situations; second, to minimize damage if breakage does occur. In the spring of 2011, we repositioned / replaced the Cobra® cabling systems. This was done for two reasons: one, the trees had grown enough during the past five years that the cables needed to be repositioned to provide maximum support; two, the manufacturer recommends replacing the cables at 5 year intervals because of deterioration of the materials due to repeated physical stress and constant environmental exposure to sun, heat, cold, wet, wind, etc. Minor **deadwood** and

Photo 4 – Cobra® cabling system installed in one of the silver maple trees.

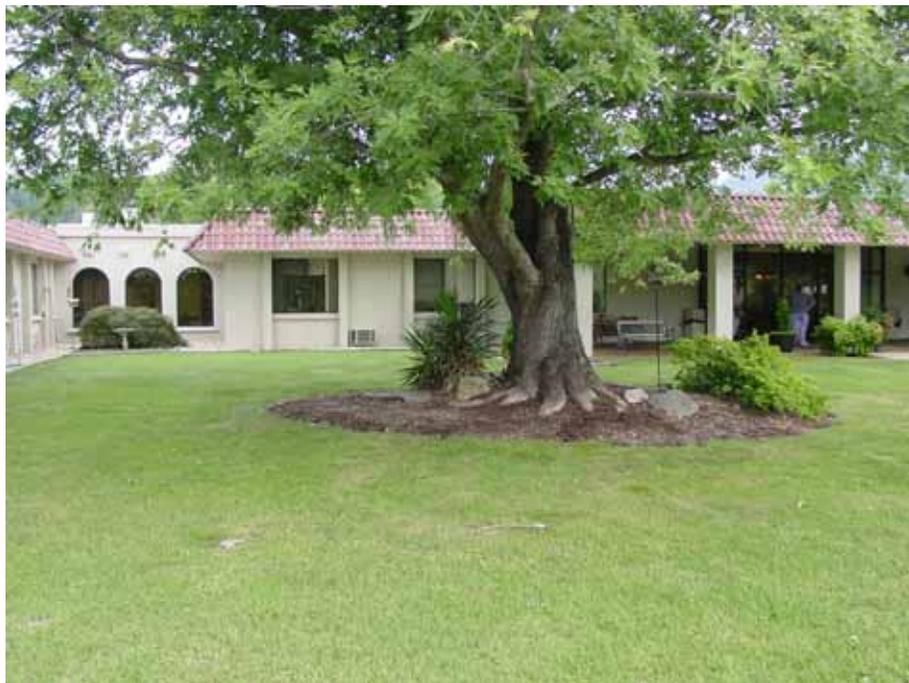
The numerous surface roots from these trees make mowing the lawn under them very difficult. Walking can be hazardous due to the multiple trip points caused by the roots, especially for older and rehabilitating patients. The mounding at the base of the trees is beginning to impede the positive surface drainage away from the building. Subsurface drain pipes were not inspected during this evaluation, but it is very possible that they are being affected by tree roots, or will be affected in the future. No evidence was found that tree roots were cracking or heaving the building foundations, which was a concern of the architects. However, given the nature of silver maples, it is entirely possible that these trees have caused, or will cause, some structural damage to the building. Exploratory digging would be needed to properly evaluate actual or potential structural damage; this evaluation is based solely on visual observation. As the trees grow and the roots continue to expand in diameter, all of the problems listed above will get worse.

Structurally the trees appear sound. They have good root flare and trunk taper. Their limbs are normal in size and distribution, and no dangerous, acute crotch angles were observed. With the newly reinstalled Cobra® cabling system the trees do not appear to be hazardous at this time. However, the species in general has a reputation for breaking apart during storms, especially as they get older.

Photo 5 – Tree #4. Good root flare and trunk taper. Note the soil mounding at the base of the tree.

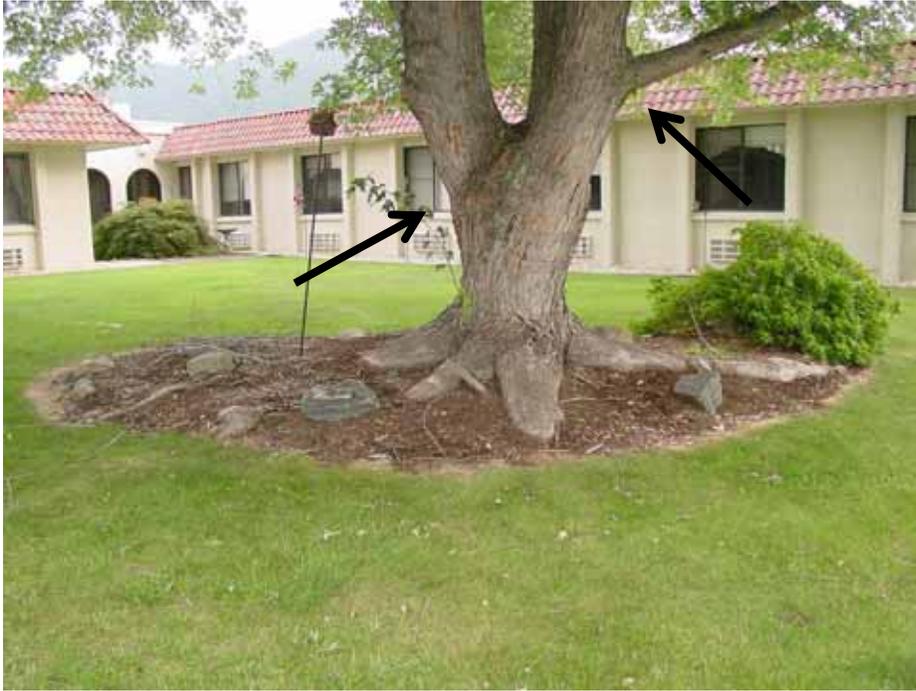
Photo 6 – Tree #3. Good crotch angles.

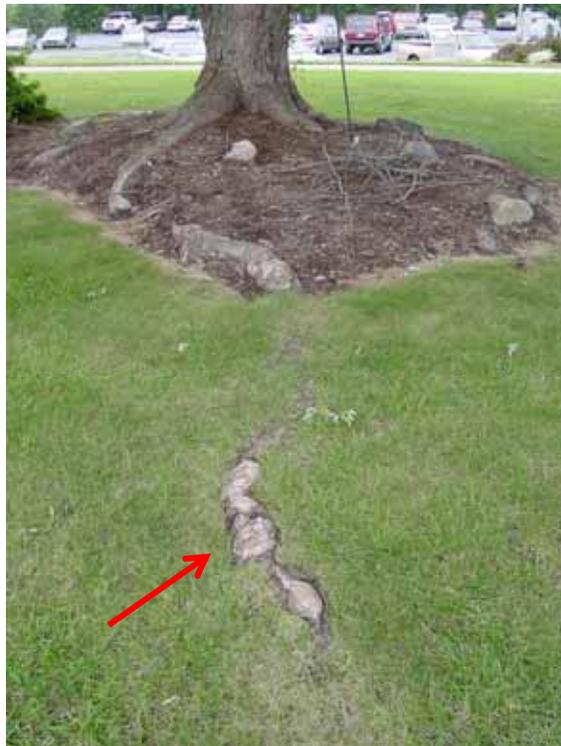
Photo 7 – Tree #3. Example of surface roots in the lawn area. Note the numerous wounds caused by mower blades, and the soil mounding at the base of the tree.

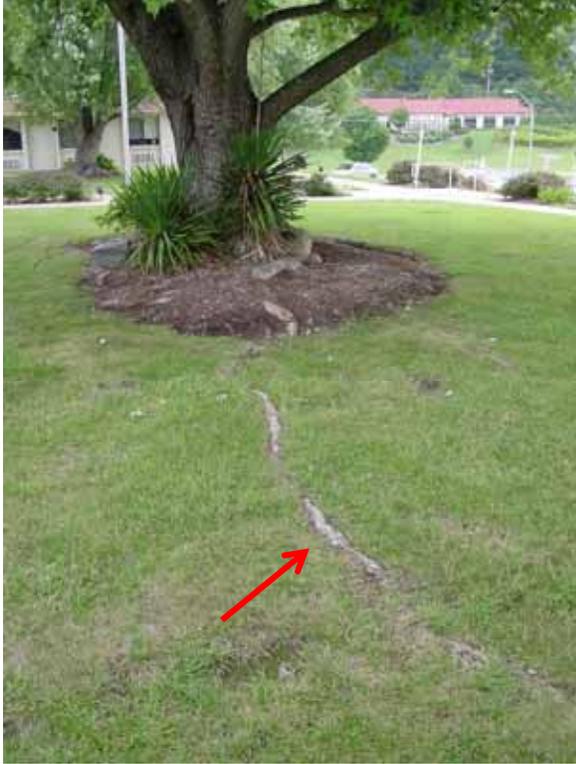
Photo 8 – Tree #4.
Another example of surface roots in the lawn area. Again, note the numerous wounds caused by mower blades.

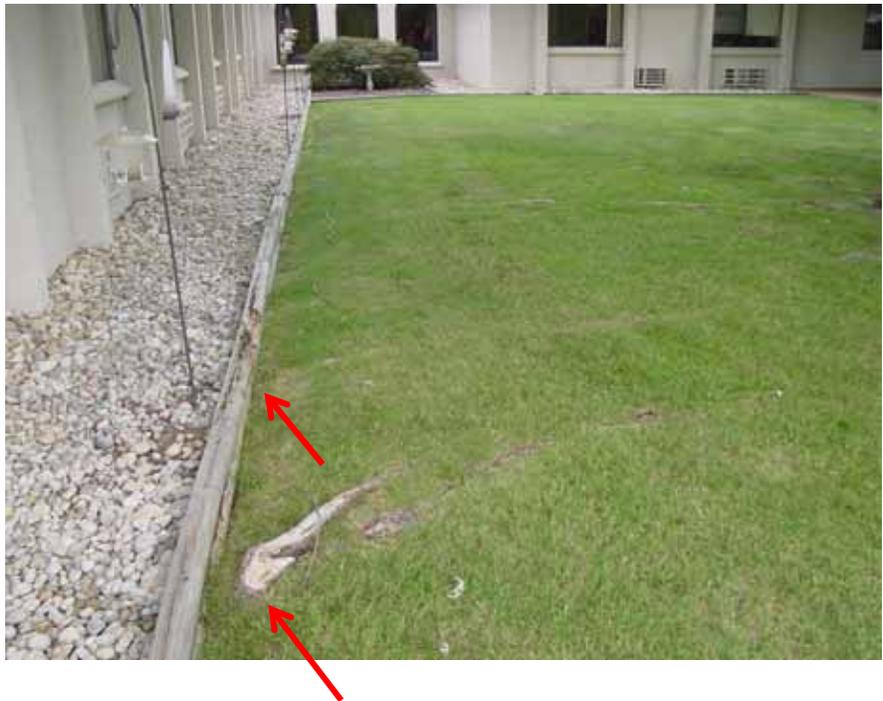
problematic for his grounds maintenance crew, and hazardous to his ambulatory residents / patients and their visitors. He also said that the architects are concerned that the tree roots might eventually damage the building foundation and adversely affect drainage systems in the area, if they have not already done so.

Photo 9 – Roots of Tree #4 close to building foundation.

There are ways to protect the building foundation and drainage system without causing permanent or potentially fatal damage to the trees. Mostly, this would involve cutting existing roots (if there are any) at a specified distance away from these structures and installing **grow-barriers** at these locations. Most of these structures occur near, or beyond, small segments of the drip line environment, so root damage from cutting would be minimal and something from which the trees should readily recover.

Essentially, a grow-barrier is something that will not allow roots to pass beyond it. These barriers can be physical or chemical, or a combination of both. The chemicals are usually specialized herbicides or growth retardants. A very effective physical barrier is a geotextile silt-barrier fabric (e.g., Mirafi 180N. For more information about this product go to www.tencate.com). The key with any barrier is proper placement; it must be placed so the roots cannot get above or below it. If installed properly and inspected regularly, these barriers should give permanent protection to the building foundation and drainage system.

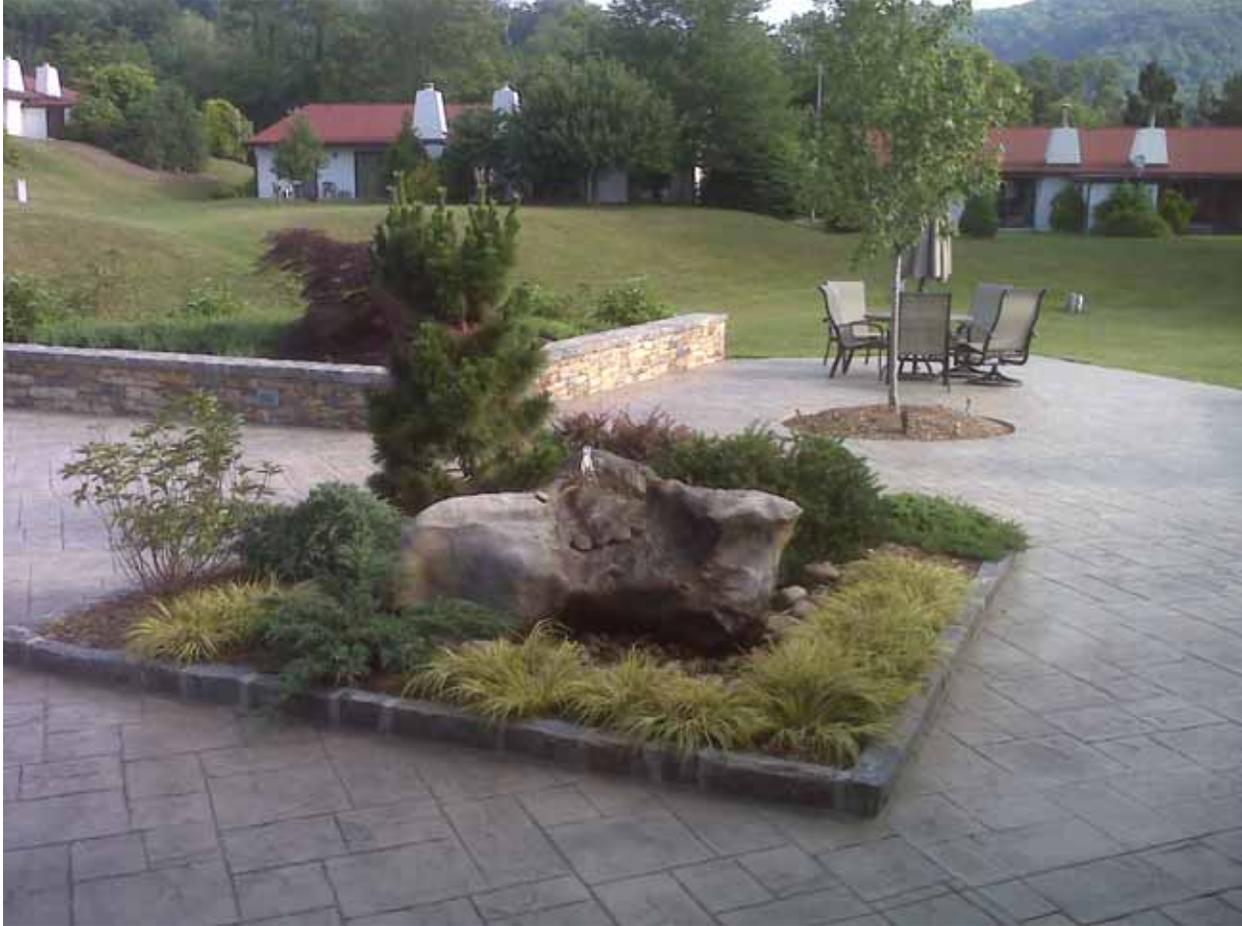
Photo 10 – Photo taken by David Kidder of new outdoor living area behind the Administration Building at Pisgah Valley Retirement Community. Photo taken 6-08-10. Project was completed in spring of 2009.

Without the trees, the space could be transformed into an outdoor living area with courtyards, patios, walkways, and gardens similar to the one built on campus behind the Administration Building several years ago (see Appendix B – Photo 10). None of these landscape elements are possible now, as construction activities to build them would be detrimental, if not fatal, to the trees. A new outdoor living area will receive more use than the existing area. It will be safer, and accessible to more people. The design of the new area can dictate future maintenance efforts, because there is control and choice involved in the design process. If the trees remain, however, they dictate future maintenance efforts, removing much of the control over future costs and efforts.
